ERRORS IN VIKING LANDER ATMOSPHERIC PROFILES DISCOVERED USING MOLA TOPOGRAPHY. Paul Withers¹, R. D. Lorenz¹, and G. A. Neumann^{2,3} ¹Lunar and Planetary Laboratory, University of Arizona, Tucson, AZ 85721, USA, ²Earth, Atmospheric, and Planetary Sciences Department, Massachusetts Institute of Technology, MA 02139, ³Laboratory for Terrestrial Physics, NASA Goddard Spaceflight Center, Greenbelt, MD 20771, USA (withers@lpl.arizona.edu).

Abstract's Abstract: Each Viking lander measured a topographic profile during entry. Comparing to MOLA, we find a vertical error of 1–2 km in the Viking trajectory. This introduces a systematic error of 10–20% in the Viking densities and pressures at a given altitude.

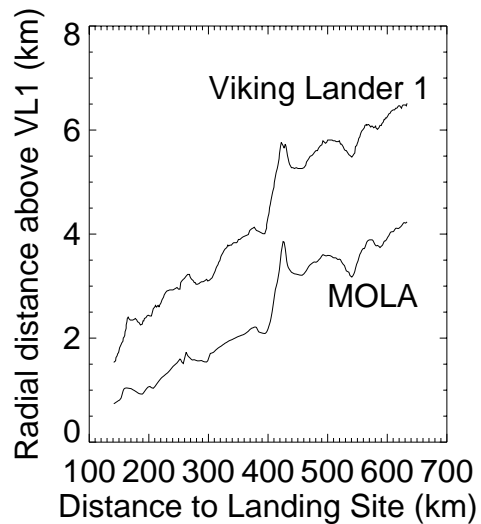
Comparison with MOLA data: Figure 1 shows the Viking Lander 1 profile, as scanned and manually digitized from figure 13 of Seiff (1993), and the corre-

sponding MOLA profile [1]. No vertical offset has been applied. Many features in one profile can be seen at the same distance along the other profile. This suggests that the radar altimeter was working well during atmospheric entry. However, a vertical offset is present between the two profiles. The Viking 1 profile is 2.3 km too high at 640 km distance from the landing site. The spacecraft is at approximately 130 km altitude at this time. This offset decreases, approximately linearly, to 0.8 km at 140 km distance from the landing site. The spacecraft is at approximately 30 km altitude at this time. Since the spacecraft trajectory is referenced to the landing site, it is not surprising that the offset decreases as you approach the landing site.

Simple Method of Discovering Error: For skeptical readers, a quick and simple way of discovering the offset is to examine the MOLA 1 degree planetary radius dataset. No region 6 km above the Viking 1 landing site is closer than about 1000 km to the landing site, significantly further away than the 600 km or so inferred from Seiff's figure.

Implications for Viking Atmospheric Structure Results: A vertical error on the order of 2 km is present in the Viking Lander 1 entry and atmospheric structure reconstruction. Errors in latitude and longitude are small, on the order of tenths of a degree. For a scale height of 10 km, this corresponds to published densities and pressures at a given altitude being systematically incorrect by approximately 20%. Atmospheric temperatures are minimally affected. The boundary layer wind studies of Seiff (1993) are severely affected by this offset [1].
